Home Inspection Report

555 Windhammer Road Portland, Oregon 97220

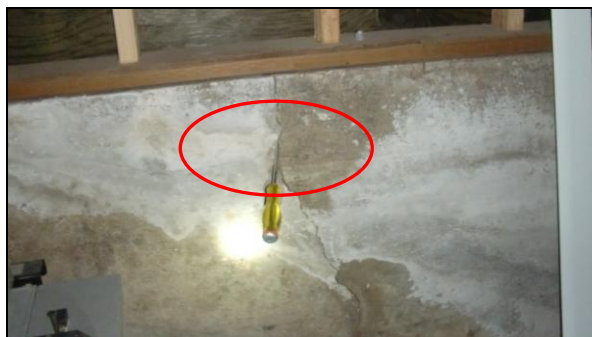
Photo 1STR: This settlement crack runs diagonally and is larger than typical. This crack should be sealed on the exterior and monitored for any potential widening.

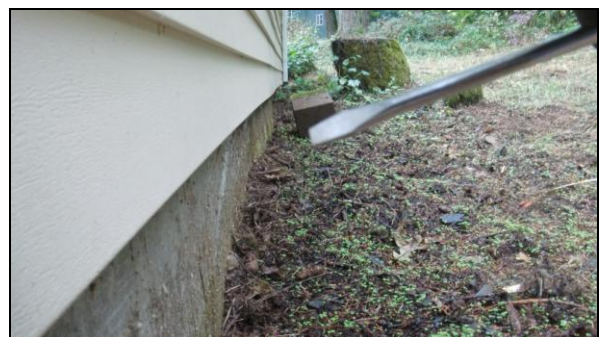
Photo 2STR: Outside view of this wall shows signs of bowing inward and outward. This may be an original flaw in setting the concrete. Recommend water be properly drained away.

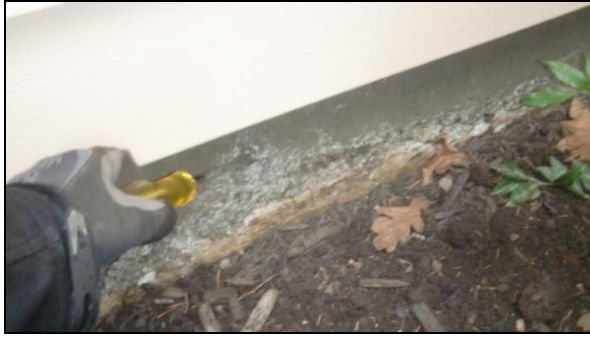
Photo 3STR: Slight, localized deterioration of the base of this foundation should be repaired with a concrete parge to keep water out.

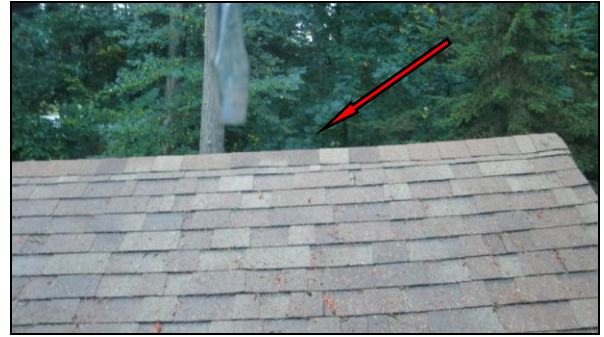
Photo 4STR: There is slight sag at the ridgeline. This is common for rafters but should be monitored.

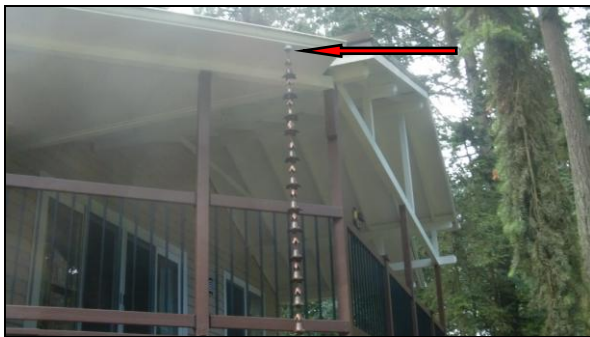
Photo 1RF: This drip spout should be replaced with a conventional downspout to keep water away from the home.

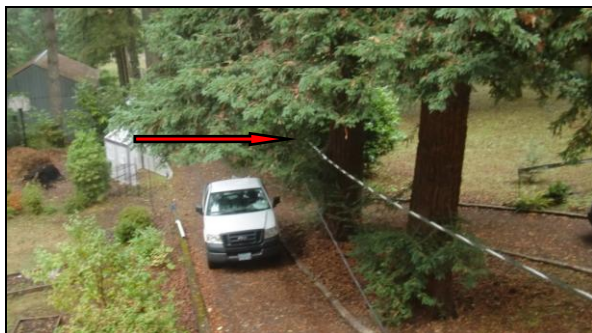
Photo 1ELE: Tree branches should be cut away from wire.

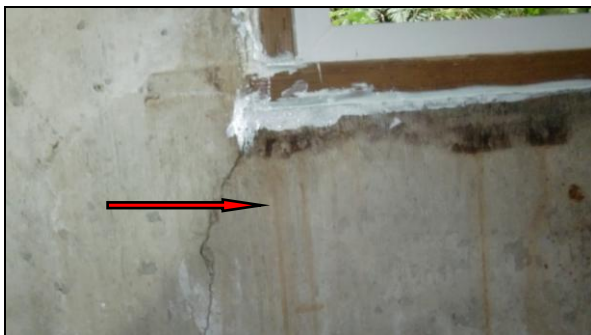
Photo 1INT: Evidence of moisture penetration was observed beneath a rear basement window.
