Yellow call-outs not a part of
the actual inspection report.

Home Inspection Report

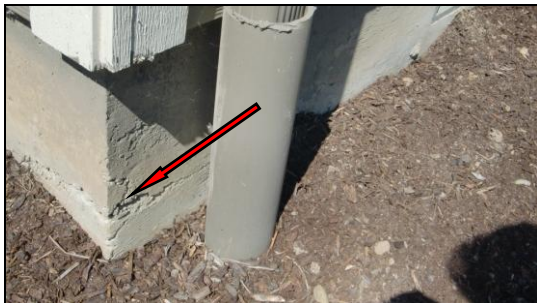
Photo 1STR: Minor spalling of this corner of home. Recommend parge/seal with concrete mixture to mitigate moisture penetration.

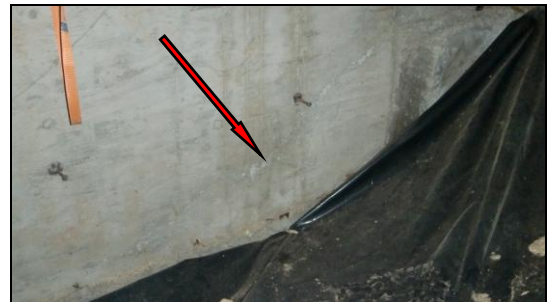
Photo 2STR: Settlement seams developed in the foundation wall in the crawlspace. This is typical and appears to have no structural significance.

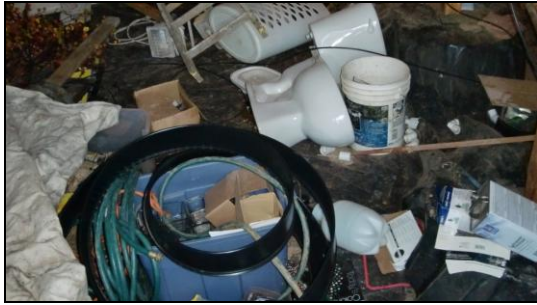
Photo 3STR: This debris in crawlspace should be removed.

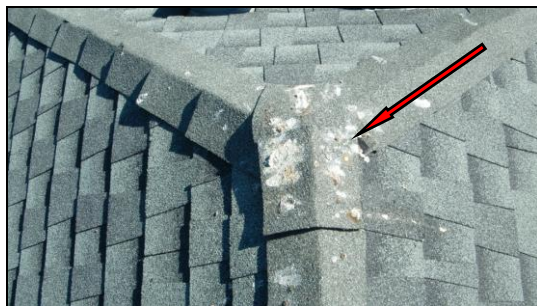
Photo 1RF: This problem may have been at installation with roofers providing extra nails to secure shingle. This is topmost ridge cap.

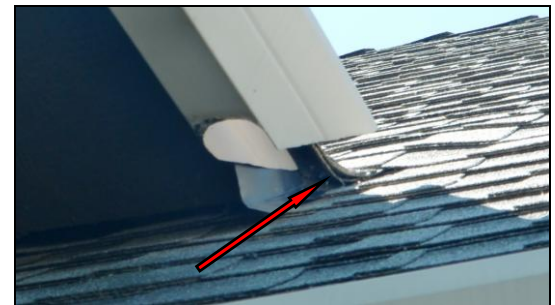
Photo 2RF: This gutter is cut to allow water to drain directly on shingles. Recommend piece of metal flashing underneath.

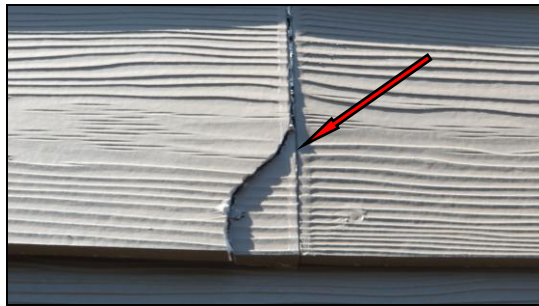
Photo 1EXT: Several panels are cracked in this way. Repair is discretionary. Recommend caulk and monitor.

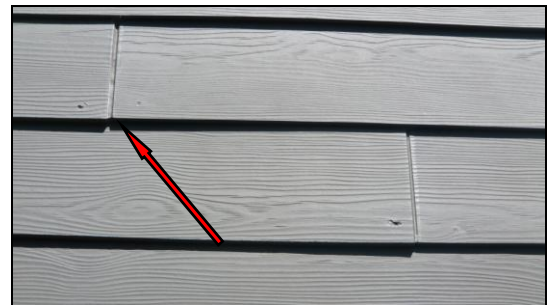
Photo 2EXT: These panels should be better secured to house sheathing.

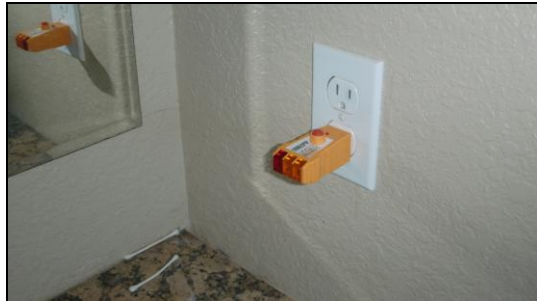
Photo 2ELE: This master bathroom outlet did not function when tested.

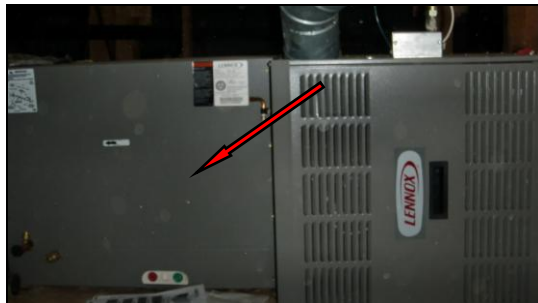
Photo 1AC: This unit is a supplemental heat pump/air handler system designed to reduce energy costs for cooling and heating. The primary system is gas furnace. The system will need an outside condenser unit and lines connecting it for operation. This is discretionary. Good system to have.

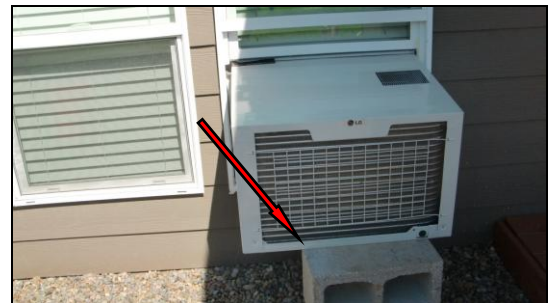
Photo 2AC: This mount is not recommended. The unit should be sitting on more of the concrete block.

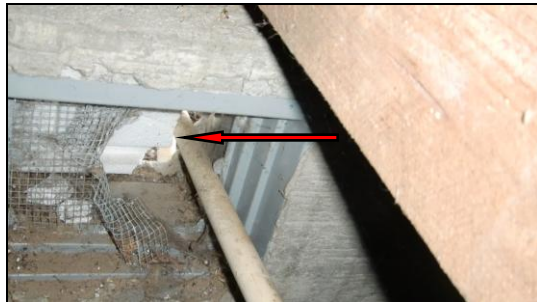
Photo 1INS: This vent screen is torn away to allow TPR piping to exterior. This hole should be covered to prevent vermin entry.

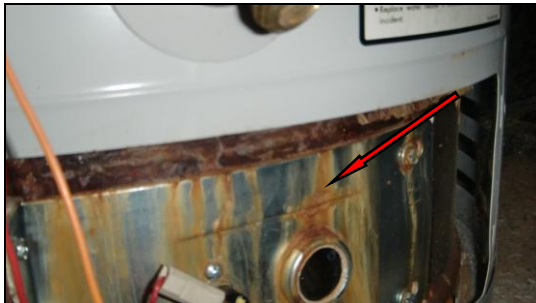
Photo 1PLU: Unusual rusting is taking place around the water heater burner unit. Recommend service to determine problem.

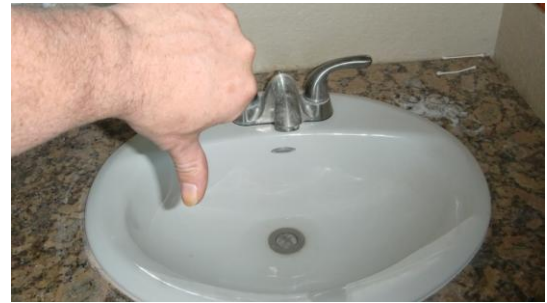
Photo 2PLU: Both sink stoppers are inop. Right side sink will not drain water.

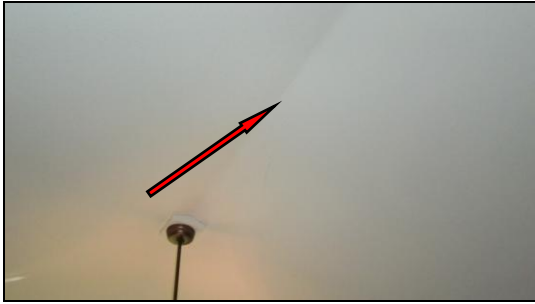
Photo 1INT: There are hairline cracks in apex of vaulted ceiling in living room. This is a typical issue with drywall and is not a major concern.

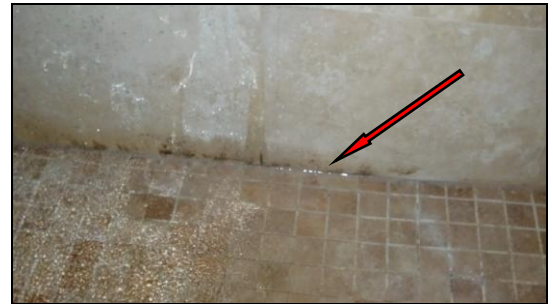
Photo 2INT: Mildew is accumulating at the base of this shower in master bathroom. Recommend clean this.

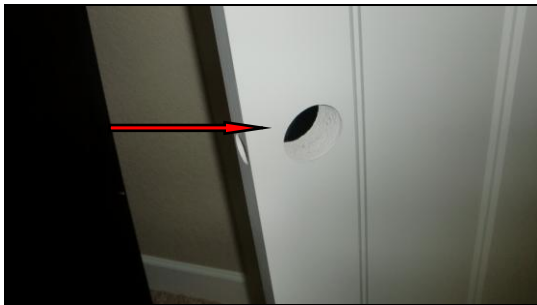
Photo 3INT: Guest bedroom closet door is missing a handle. Easy fix.

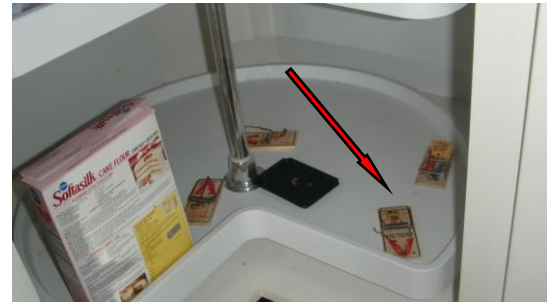
Photo 4INT: Several mouse traps were discovered in various kitchen cabinets. Recommend seal crawlspace exterior vents and clean all food particles from cabinets to mitigate.

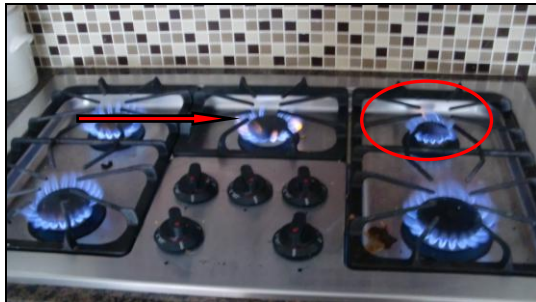
Photo 1APP: Burner with arrow is showing unusual amounts of yellow flame. Circled burner is much lower flame. Recommend spouts be cleaned.
